EFFECTS OF AIRFRAME GEOMETRY
ON DOWNWASH PROBLEMS OF
TANDEM DUCTED-PROPELLER
VTOL AIRCRAFT

DATE Jan. 1964 REPORT NO. 179T80-6

Prepared Under Navy,
Bureau of Naval Weapons
Contract N0w61-0926-c

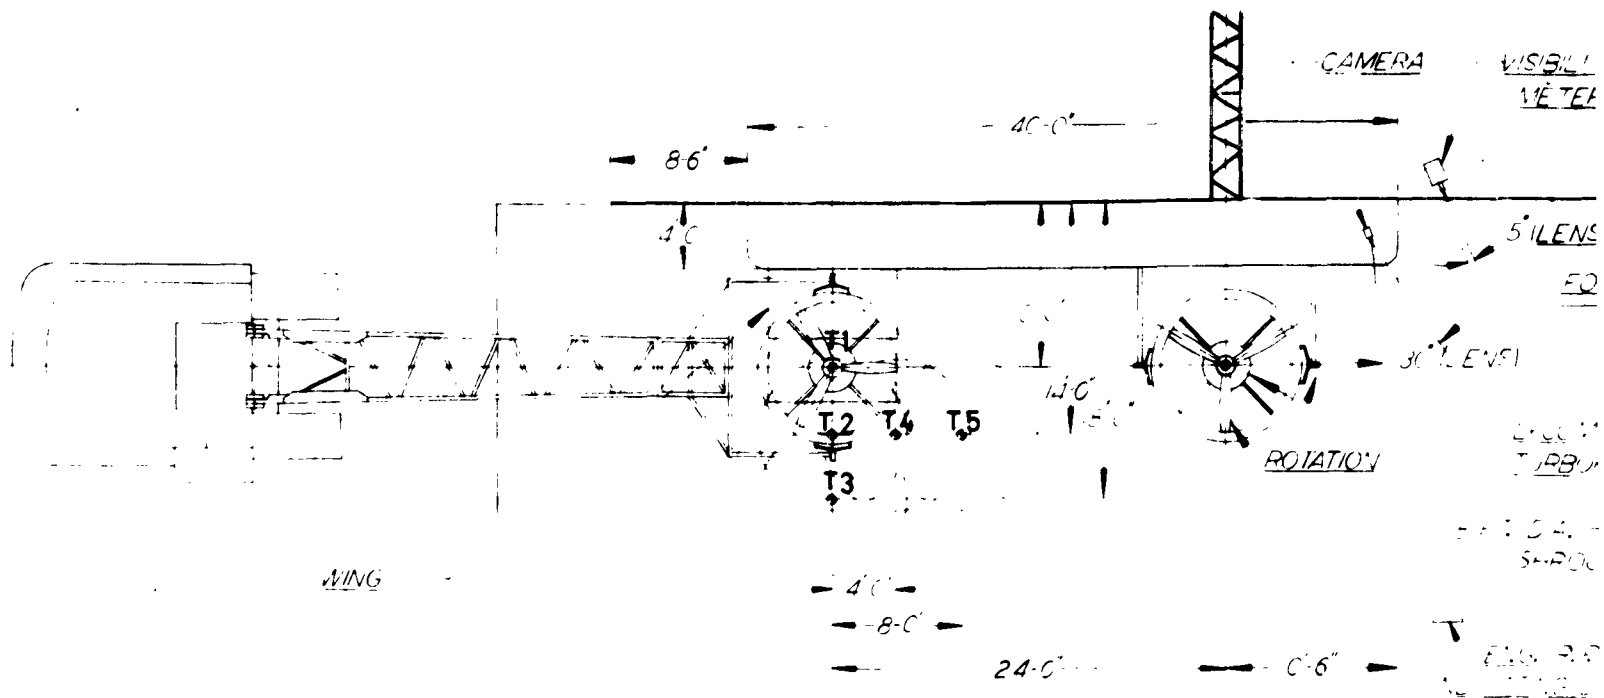
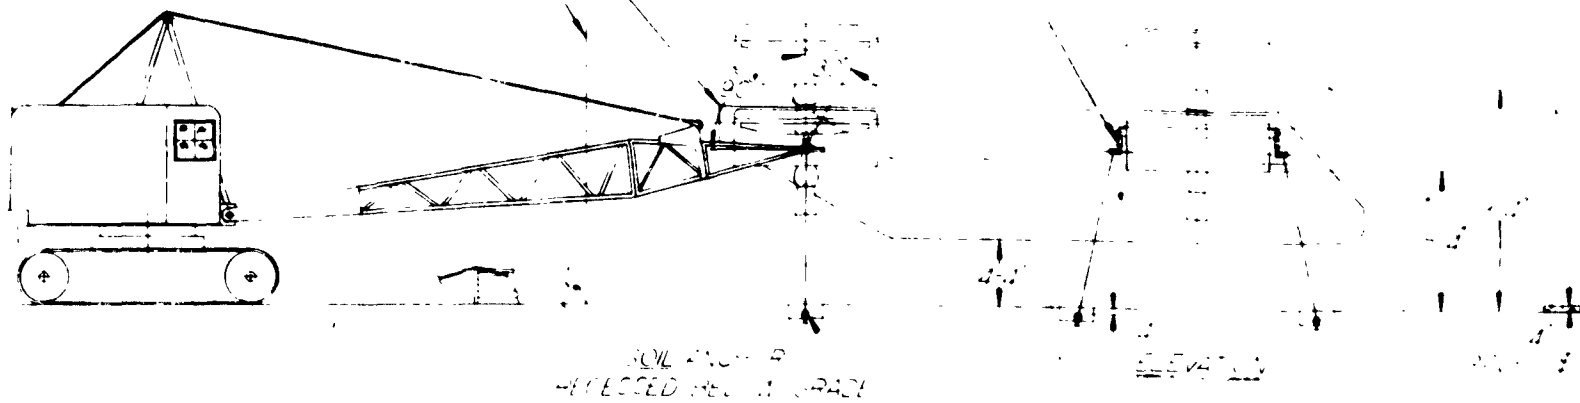
FIGURE 1
GENERAL ARRANGEMENT DOWNWASH TEST RIG
TANDEM DUCTED PROPELLER VTOL

Basic configuration details are shown in Figure 1. Five locations of the aft ducted propeller were tested. These configurations were identified as T1 to T5 depending on the duct location as shown in Figure 1. The engine inlets were unprotected for these tests. Propeller protection was minimal consisting only of a readily replaceable vinyl tape. The fuselage was quite simple for these tests and included no appendages except a stub wing.

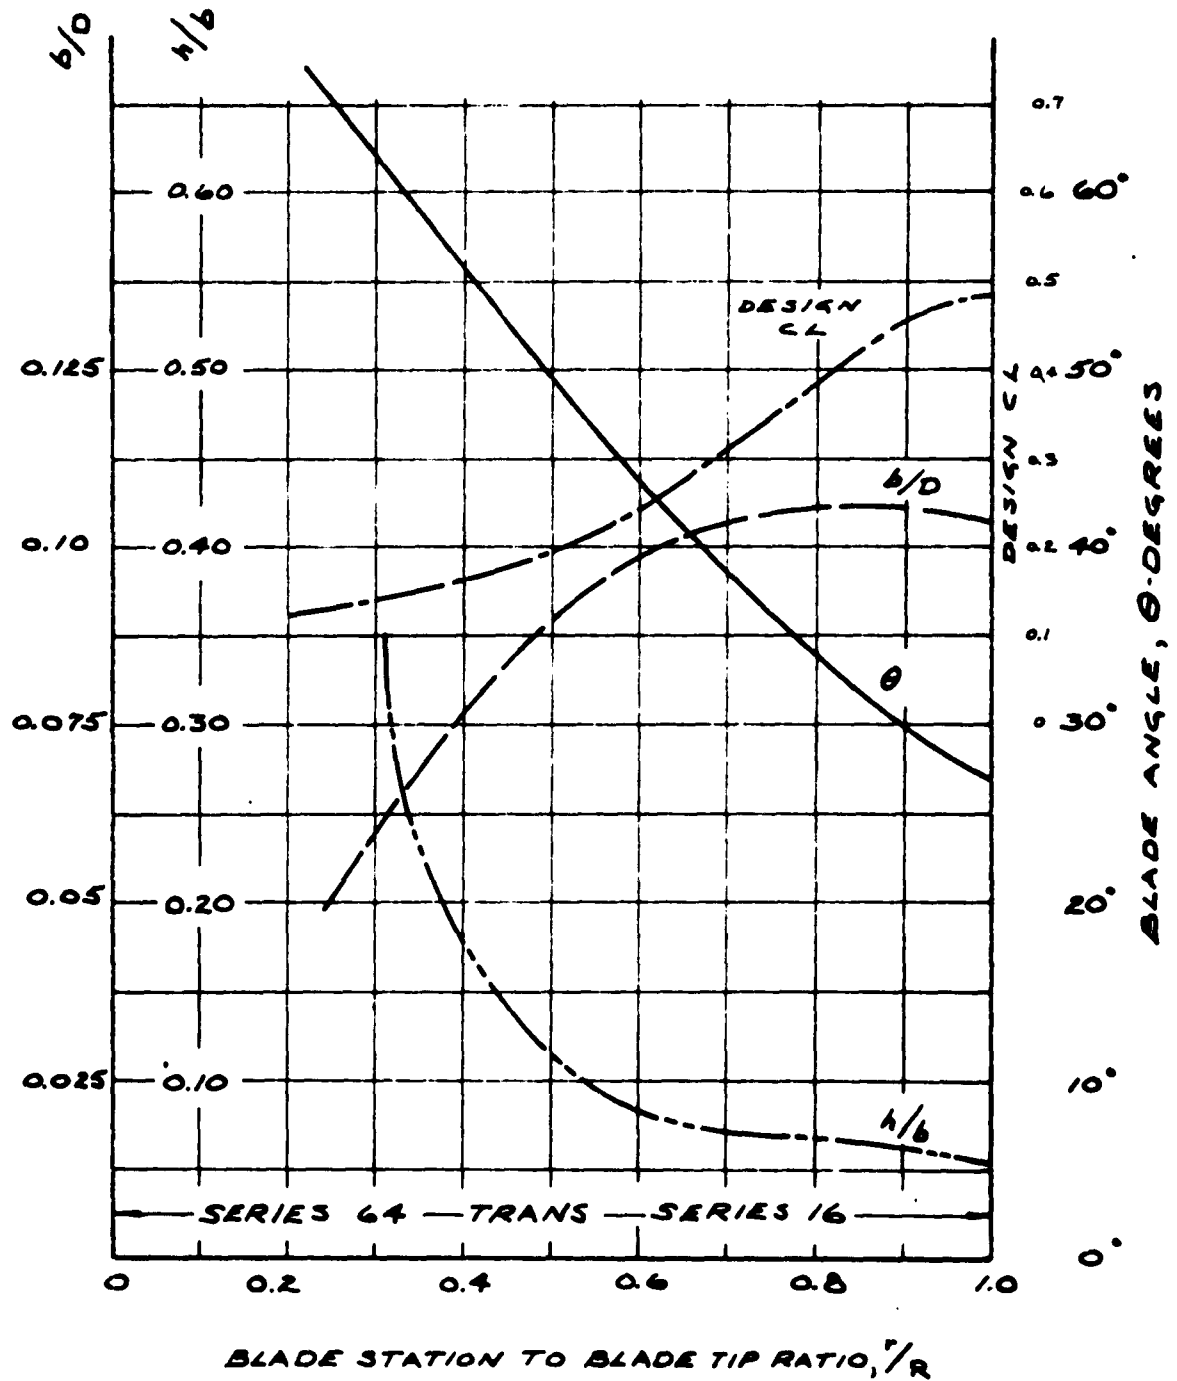
FIGURE 4. CHARACTERISTICS OF PROPELLER BLADES USED IN DOWNWASH TEST RIG

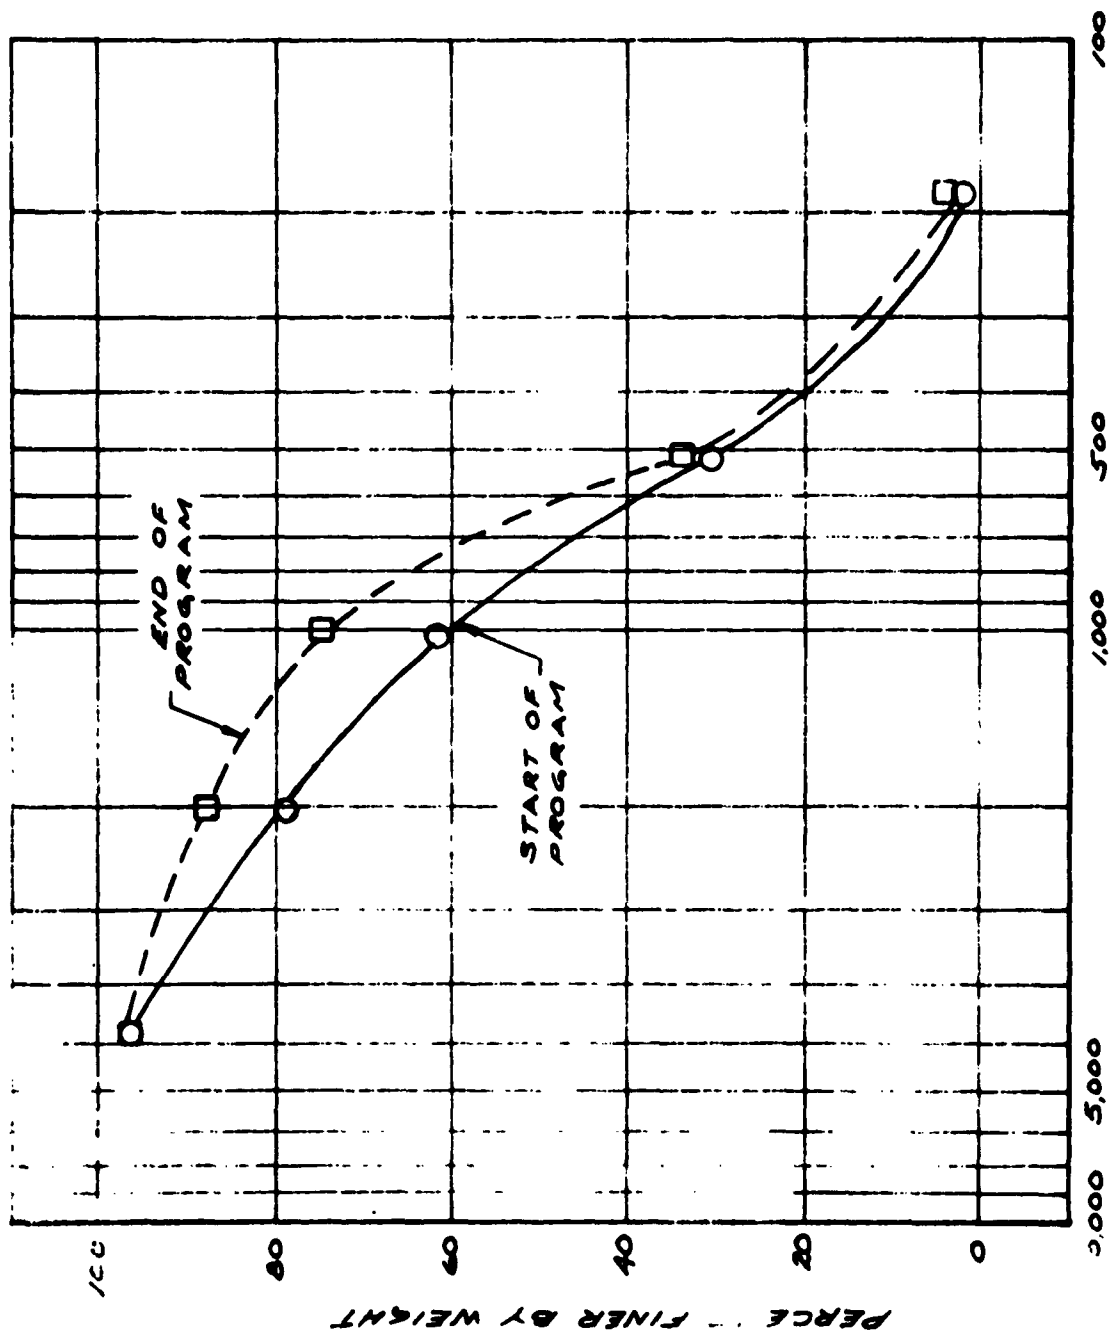
FIGURE 6. SIEVE ANALYSIS OF SAND TERRAIN SAMPLE

sand sample consisted of particle sizes ranging between 200 and 5000 microns. The particle size graduation determined by a standard sieve analysis of sand test samples, taken before and after the test runs over this terrain, is presented in Figure 6. The results shown, substantiate the observation that during the course of testing a great deal of the fine sand particles were blown away, changing the sand content. The sand had an average moisture of 11.8 percent by weight and an average density of 113 pounds per cubic foot. Photographs of the sand test configuration and a full power run over sand are presented in Figure 7.

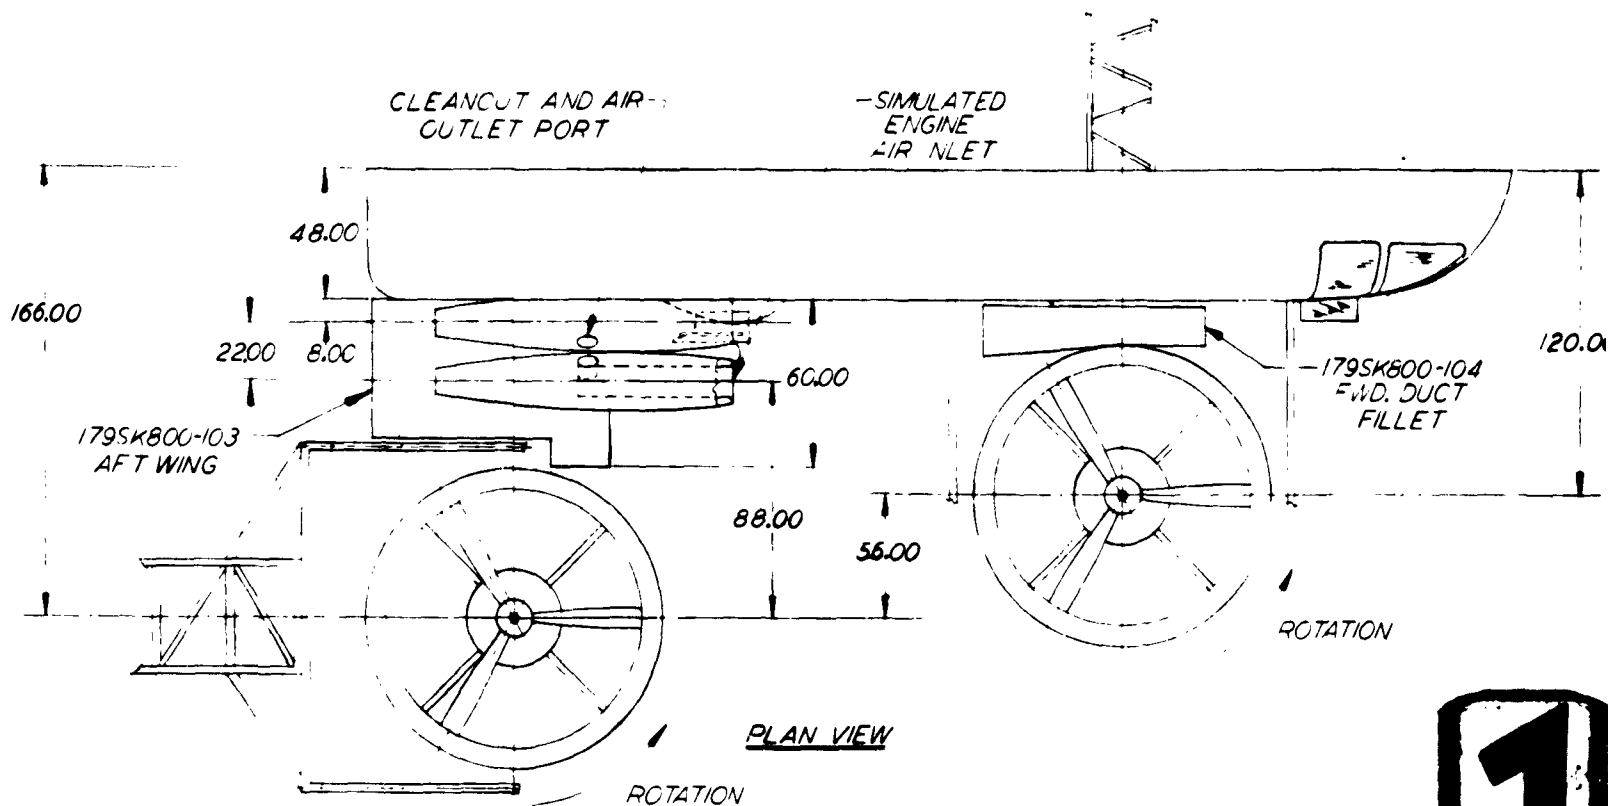
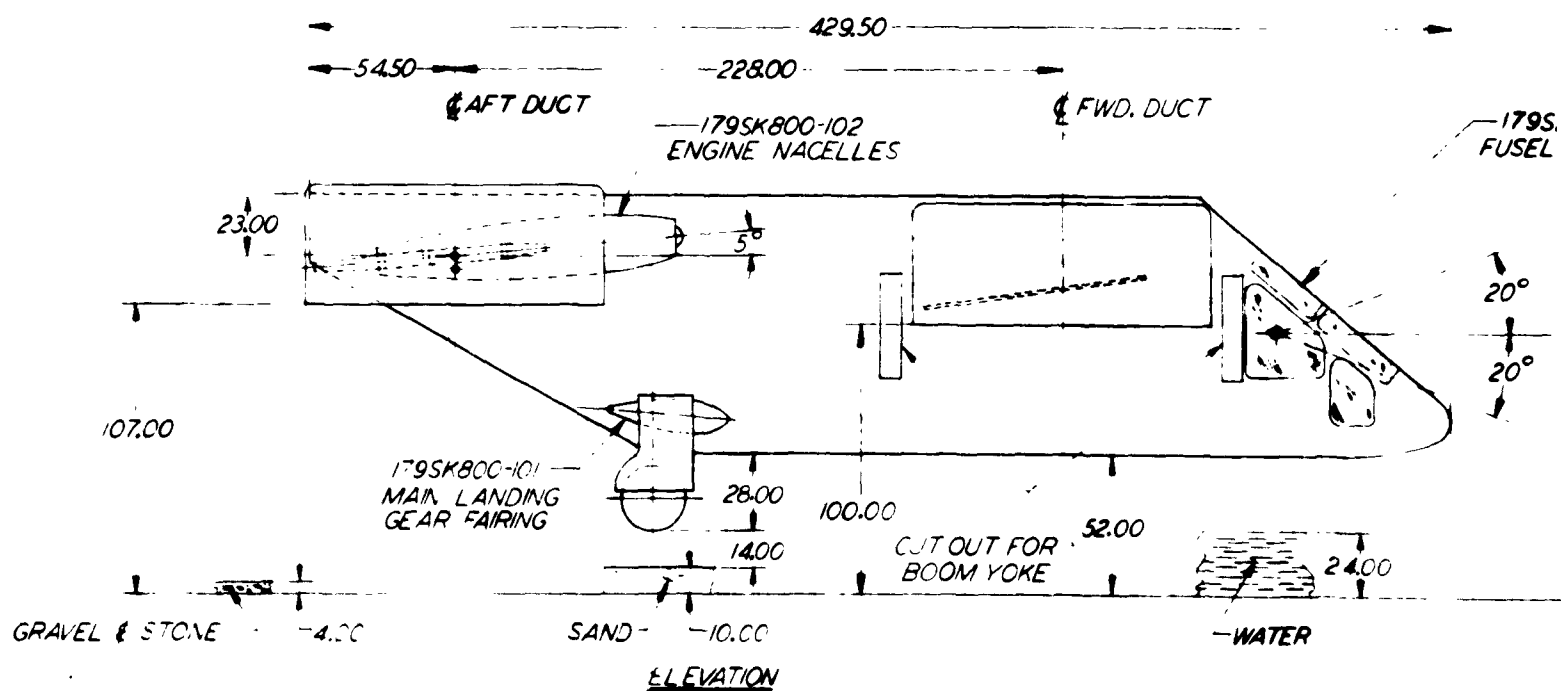
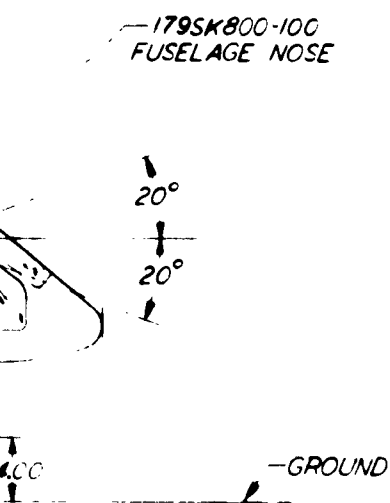
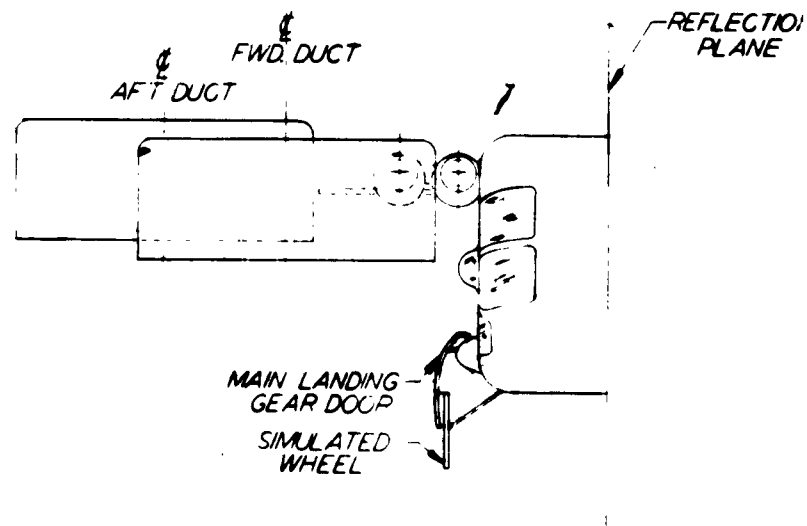
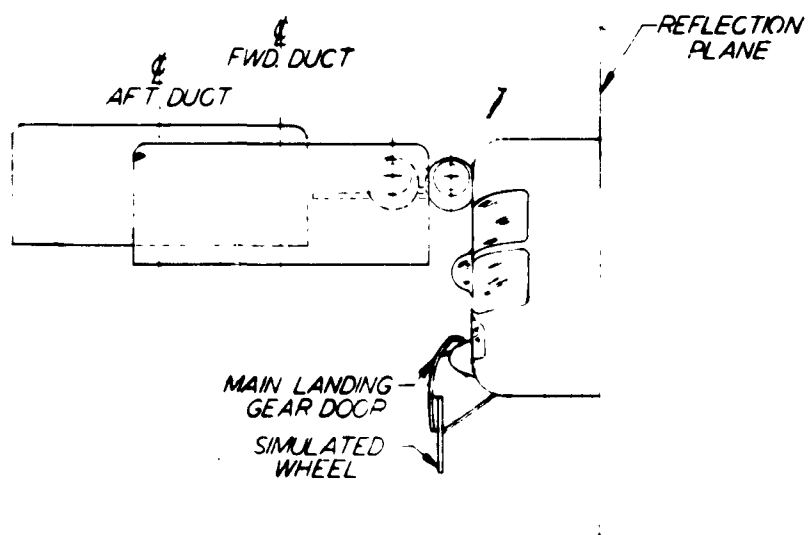
FIGURE 9. DOWNWASH TEST RIG IN MODIFIED CONFIGURATION

The Modified configuration included those appendages required to simulate a representative VTOL airplane. This configuration is shown in Figure 2, which illustrates the more representative fuselage and the addition of a dummy engine nacelle and a simulated landing gear. The design details of the modification are shown in Figure 9. A fillet was also added to the test rig which simulated the connection of the forward duct to the fuselage as can be seen in this figure. It should be noted that there was no attempt made to simulate engine flow. However, the location of the inlet cleanout ports over the stub wing as shown in Figure 9 caused a small flow to be induced through these nacelles.

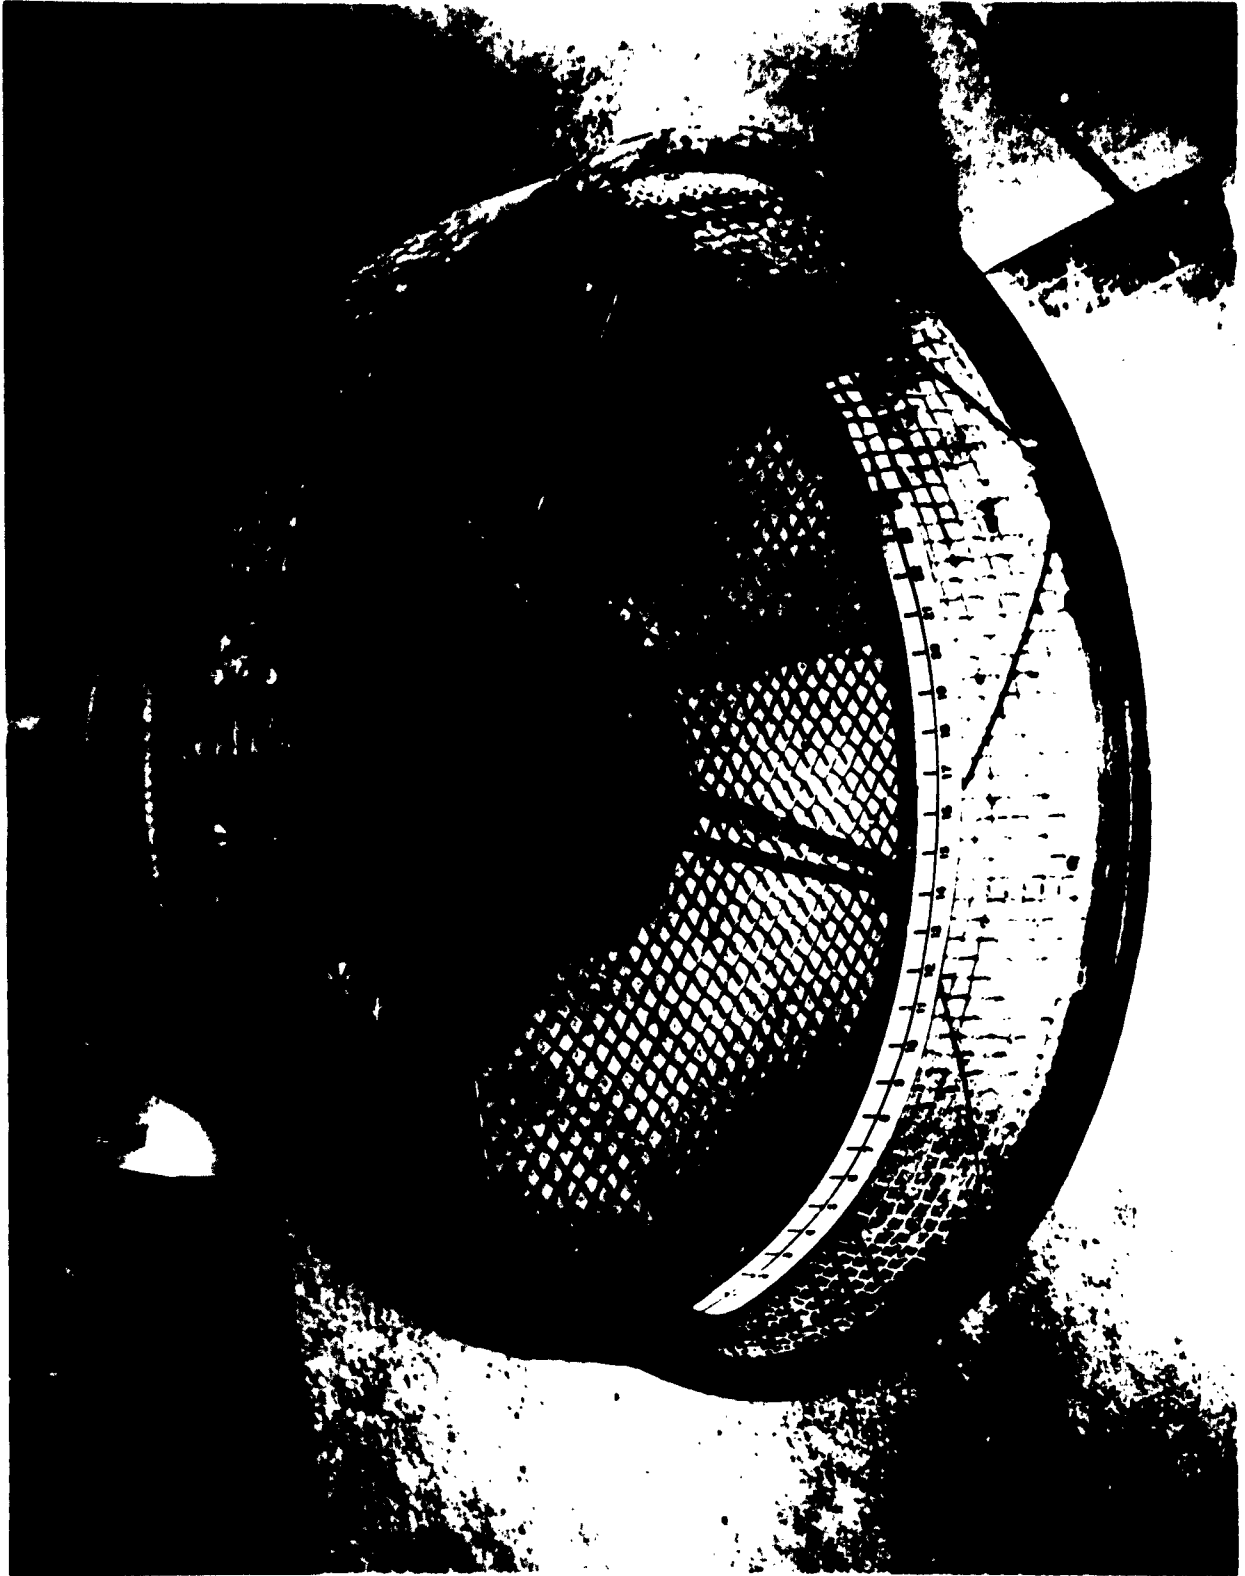
FIGURE 10. ROTATING ENGINE INLET SCREEN (36 MESH WIRE
SCREEN, 59 PERCENT OPEN AREA)

An engine inlet protection device and better propeller blade protection were also added to the test rig when the change was made to the Modified configuration. The inlet screen was mounted on the propeller hub and rotated to reduce terrain particle clogging. This screen is shown, from the engine inlet side, mounted on the propeller in Figure 10. Heavy neoprene strips were used to cover the entire lower surface and leading edge of the propeller blades as may also be noted in this figure.

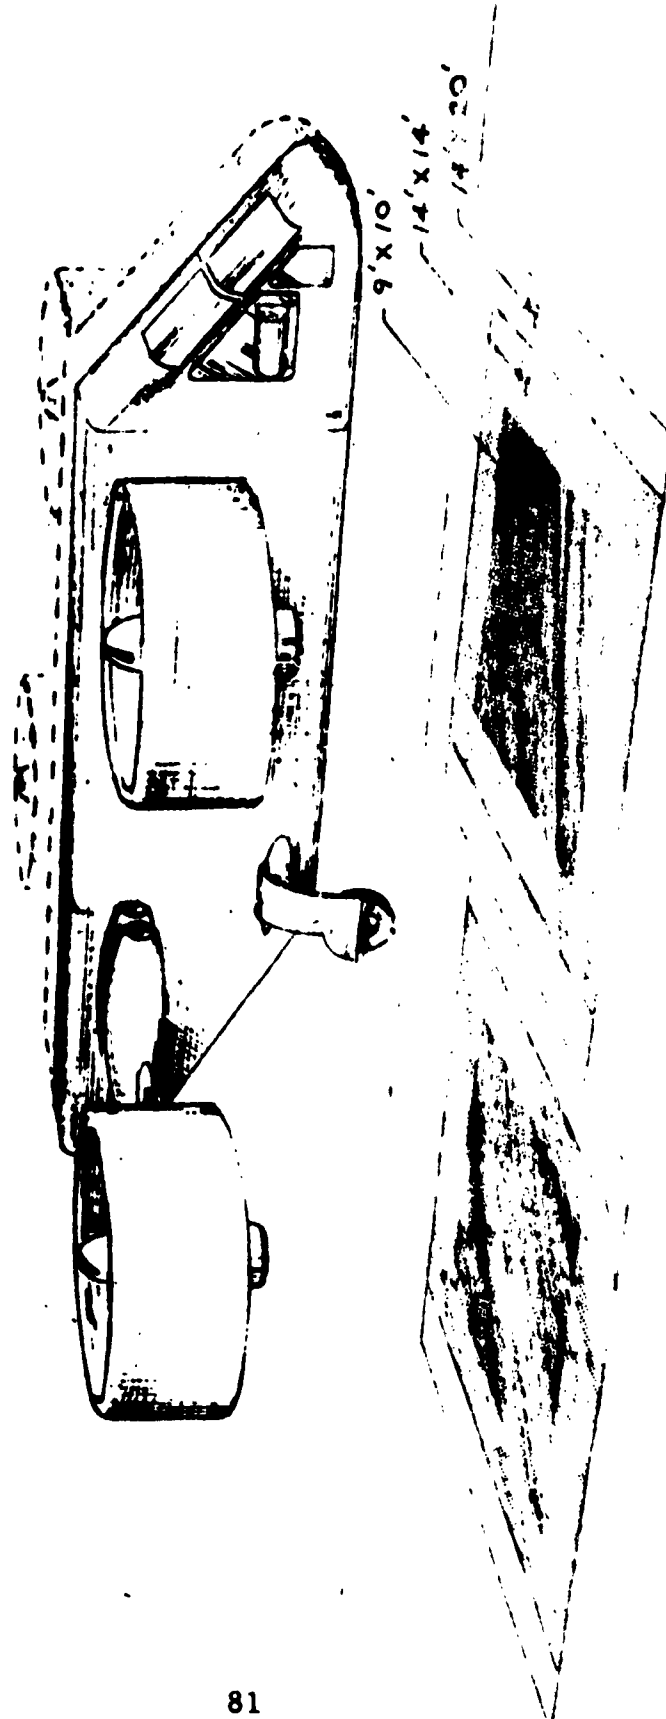
FIGURE 11. MINIMUM AREA GROUND COVERS FOR FULL SCALE TESTS

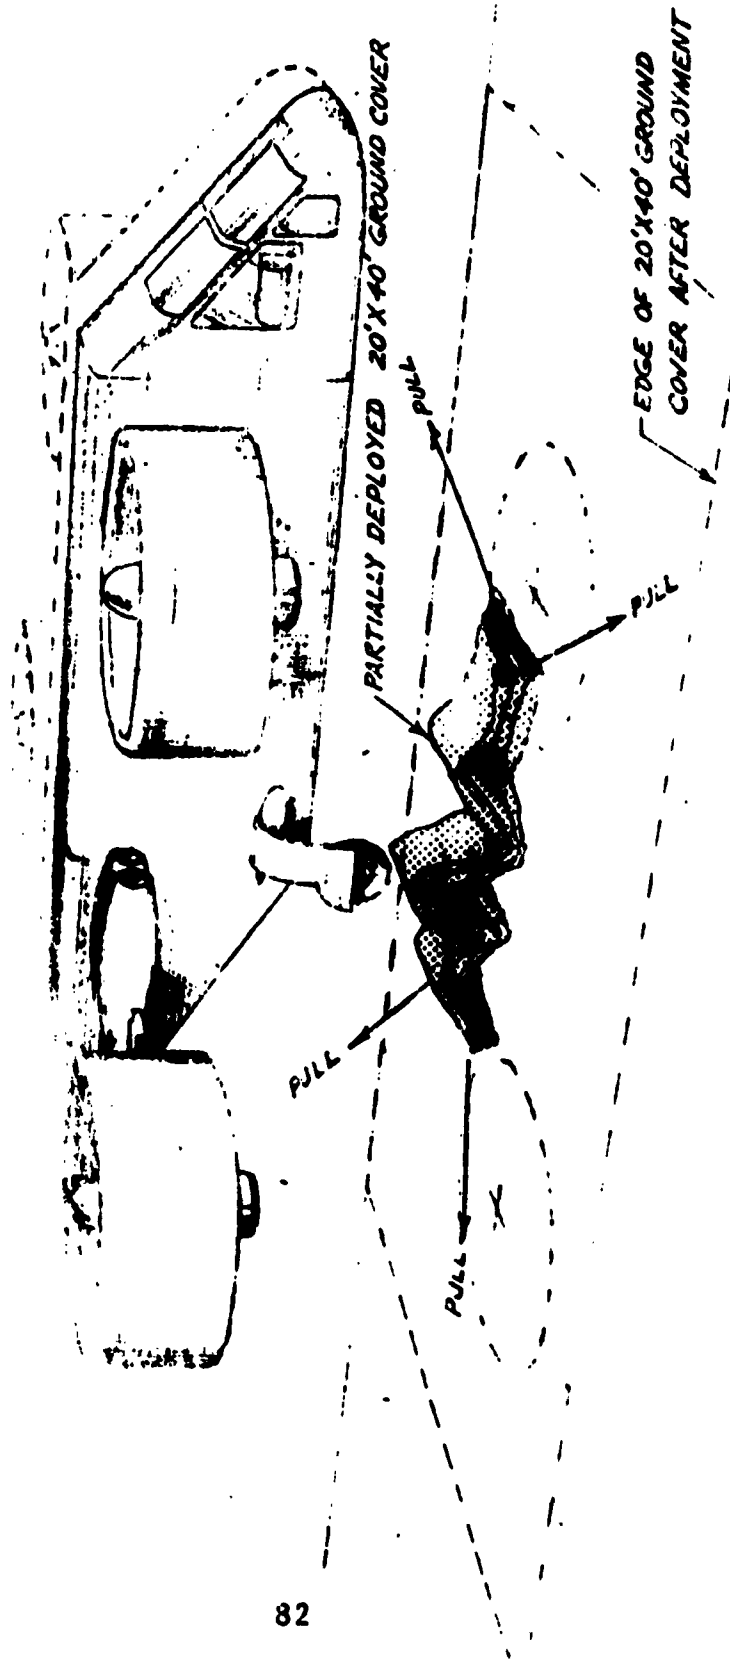
FIGURE 12. LIGHT FLEXIBLE COVER DEPLOYMENT TEST RIG

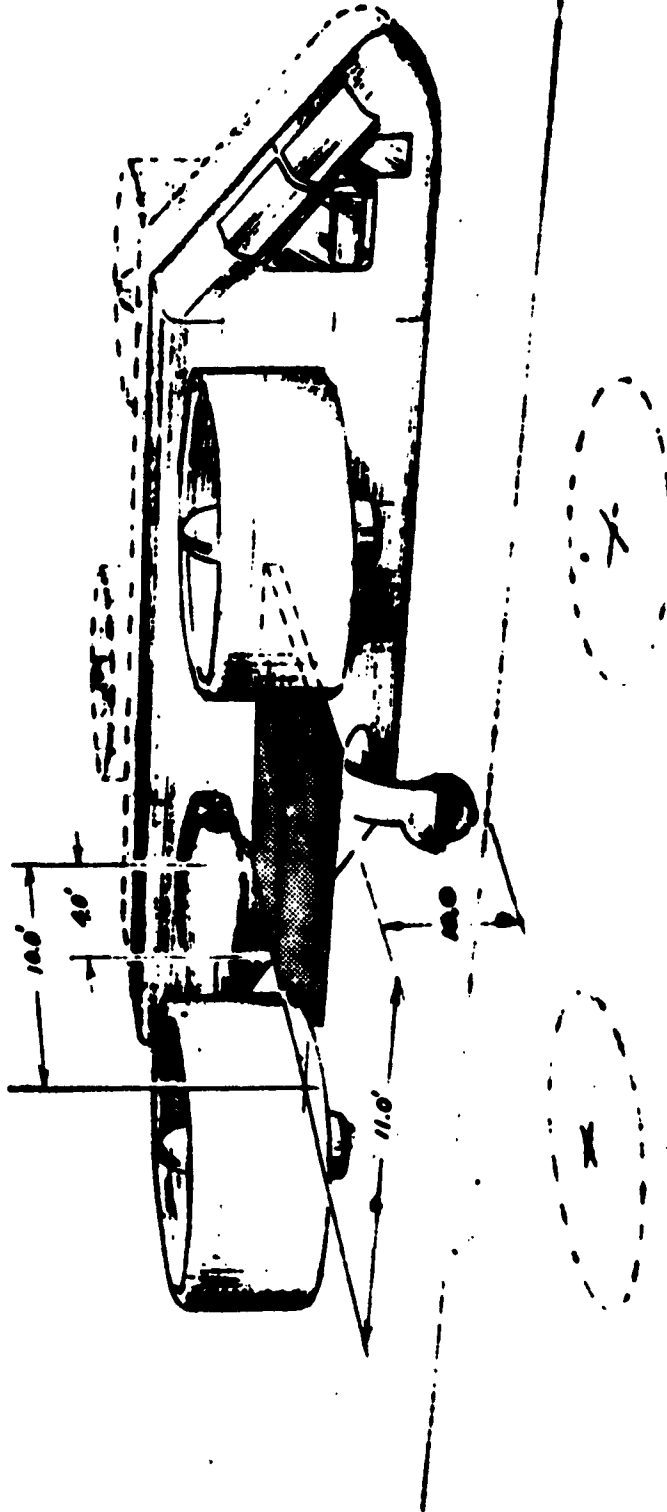
FIGURE 13. TERRAIN DEFLECTOR WING OR FLAP (SHORT AND LONG CONFIGURATIONS)

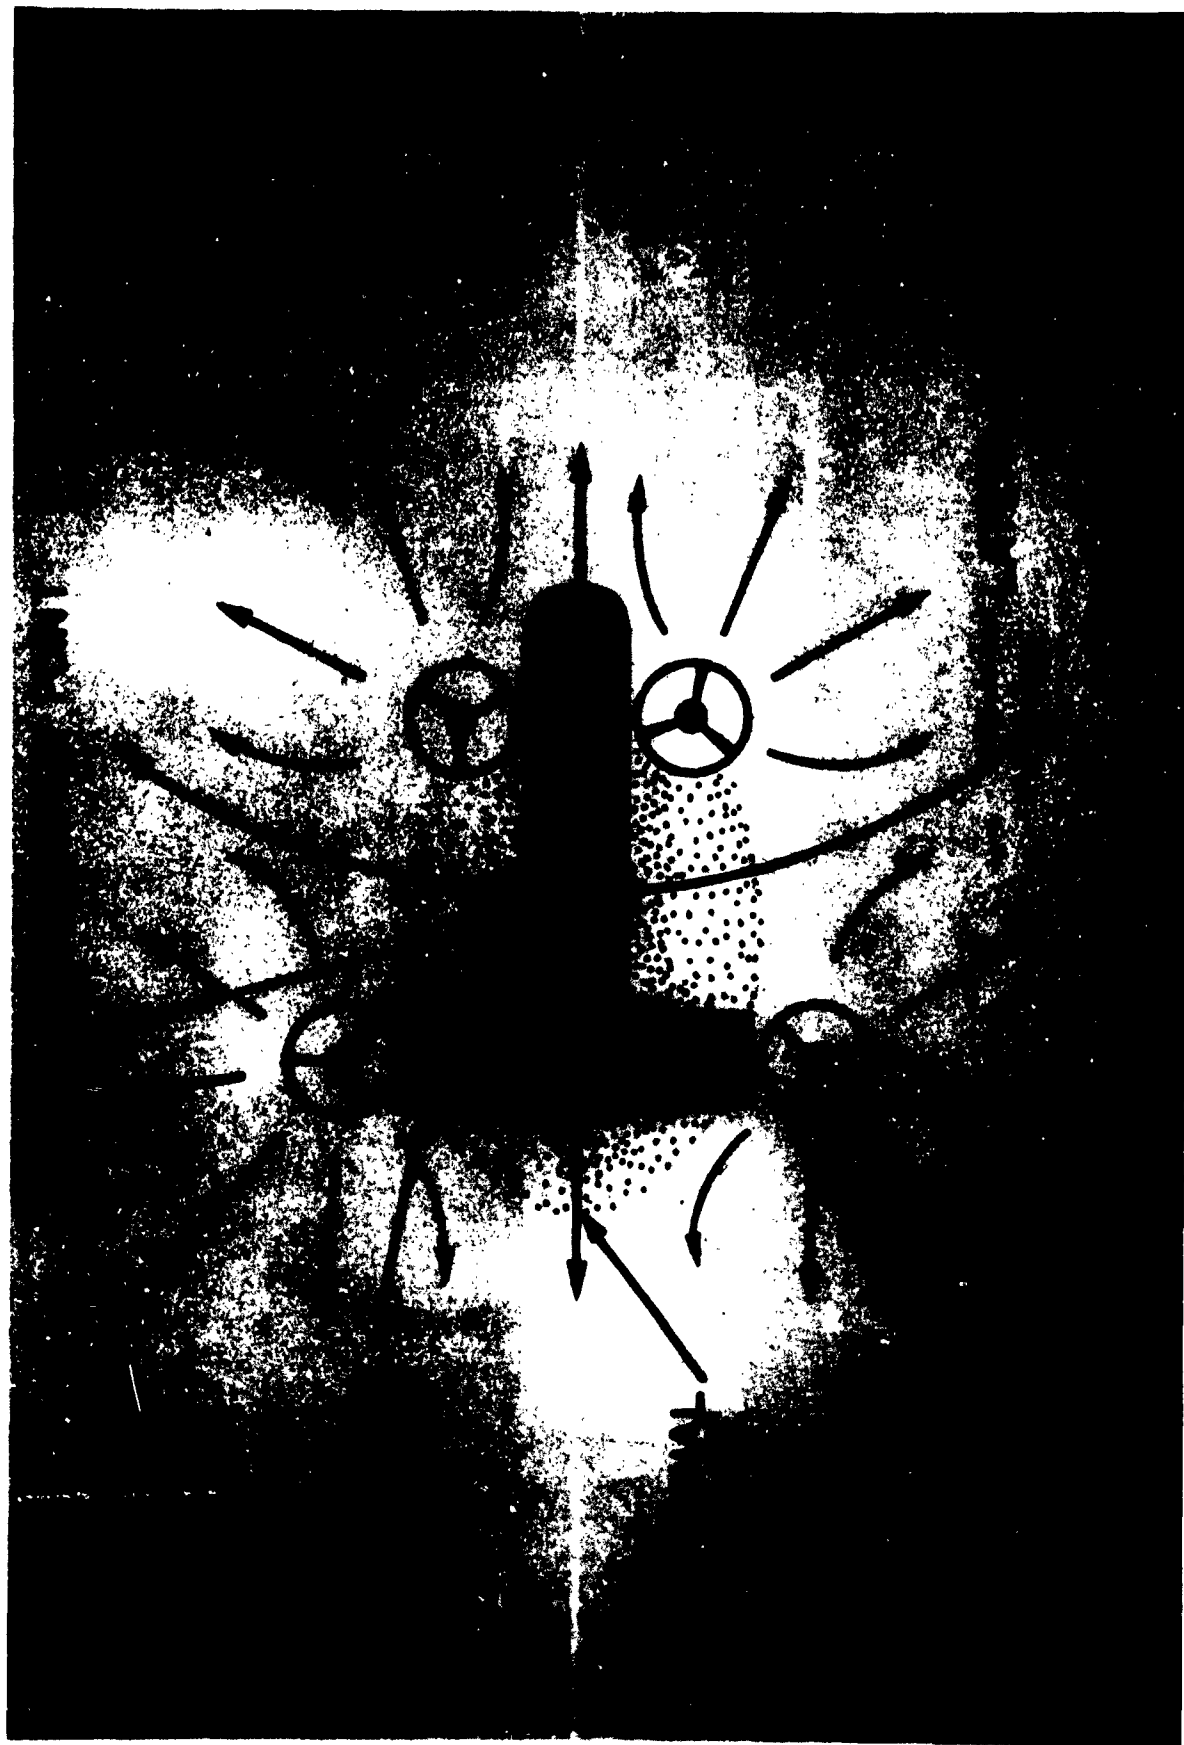
FIGURE 14. FEATURES OF DOWNWASH FLOW FOR DUAL TANDEM CONFIGURATION

The downwash leaves the propellers in a downward and radially outward direction. The interference between the flow from adjacent propellers causes the longitudinal and lateral streamlines and also causes a significantly large upflow in the area which is enclosed between the propellers. The upflow region surrounds the fuselage and can carry terrain and debris from the ground to the aircraft.

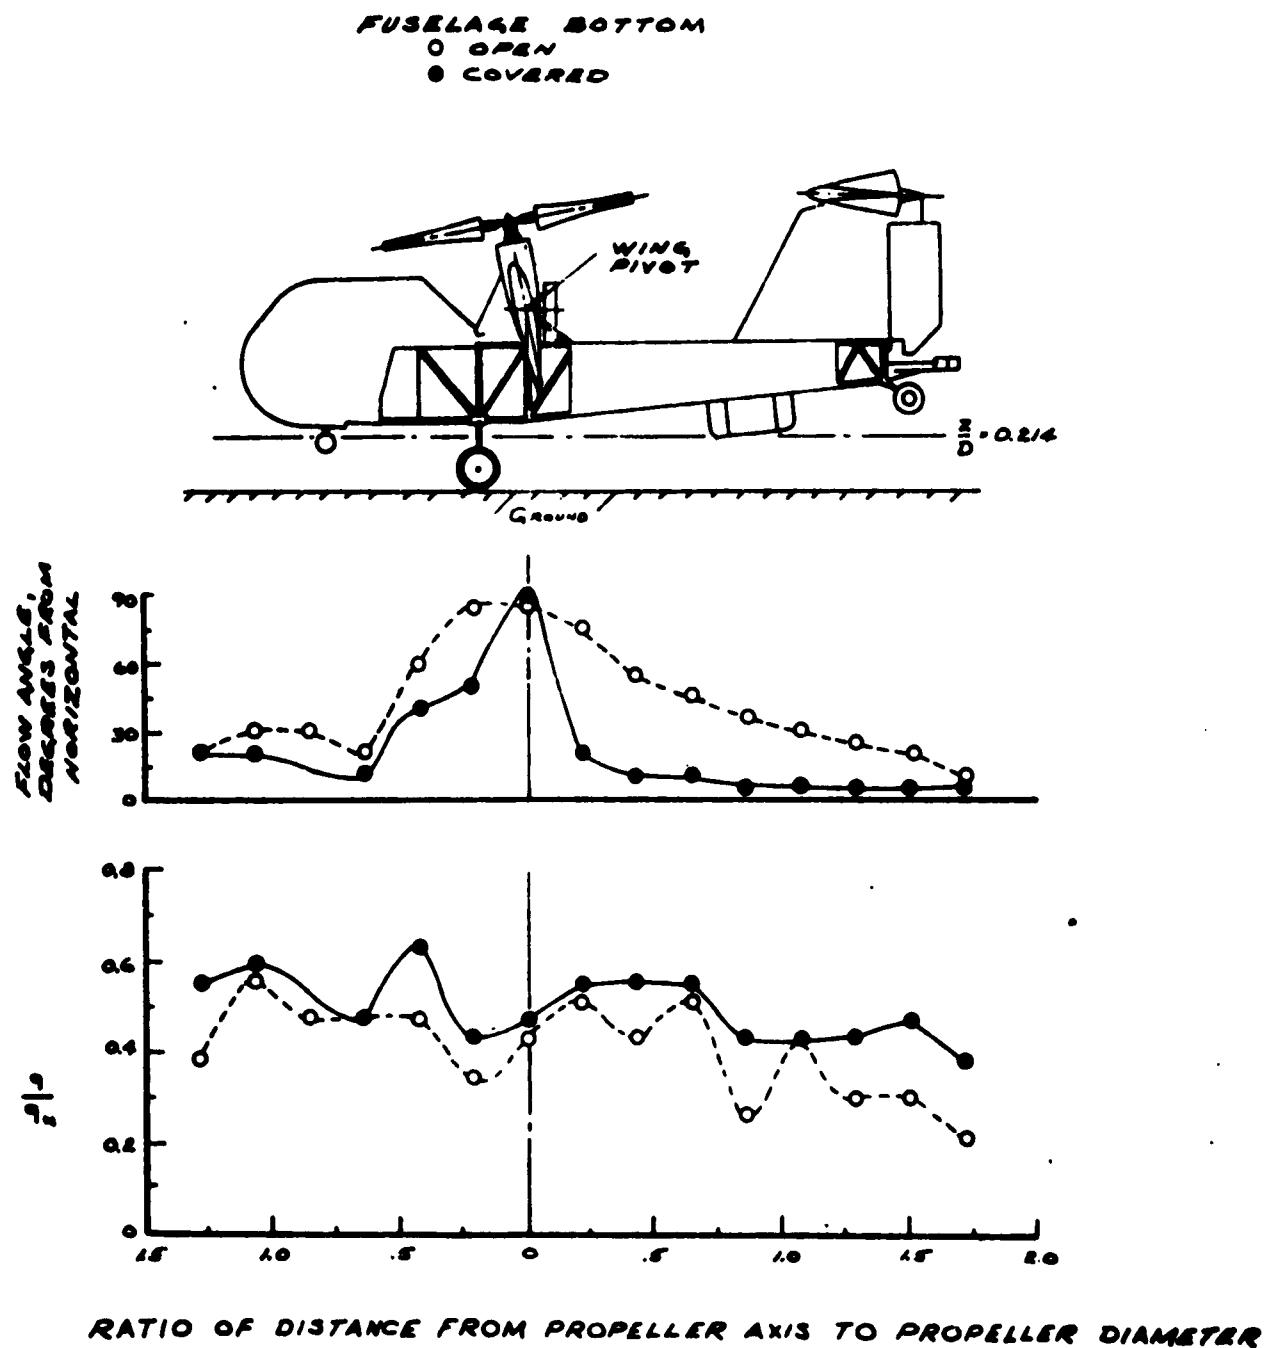
FIGURE 15. FLOW FIELD MEASUREMENTS ALONG PLANE OF SYMMETRY AND UNDER FUSELAGE OF VZ-2 MODEL (FROM REFERENCE 10)

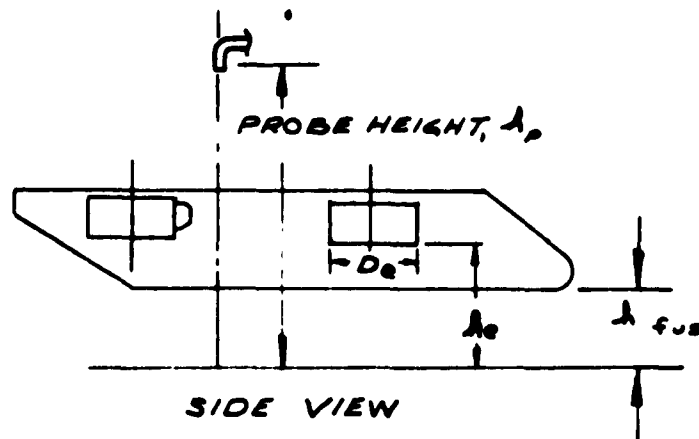
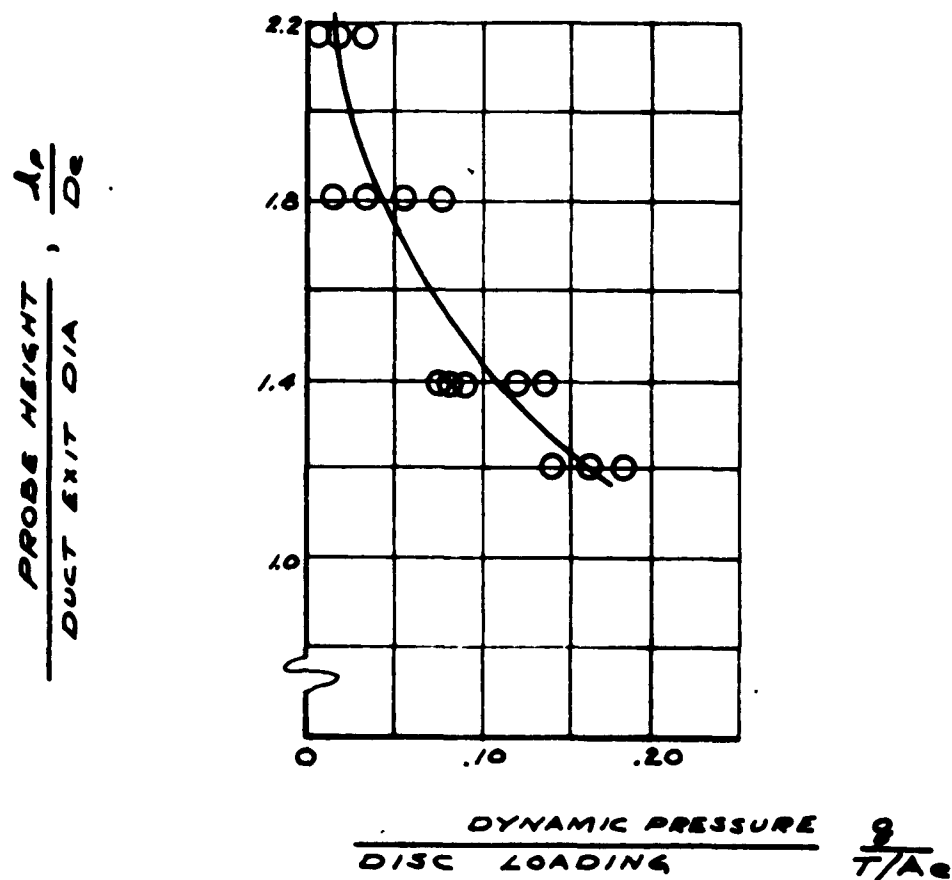
FIGURE 16. VARIATION OF DYNAMIC PRESSURE WITH HEIGHT AT POINT DIRECTLY ABOVE THE INTERSECTION OF THE LATERAL STREAMLINE AND SIDE OF FUSELAGE

The intersection of the lateral streamline and the side of the fuselage had the greatest amount of upwash. Pressure data were obtained in this region at various heights above the ground. This data is presented in Figure 16 in non-dimensional form where the ratio of local dynamic pressure to disc loading is plotted as a function of height. The scatter indicated is believed to be caused by the random direction of upflow, a phenomenon observed during the smoke studies conducted.

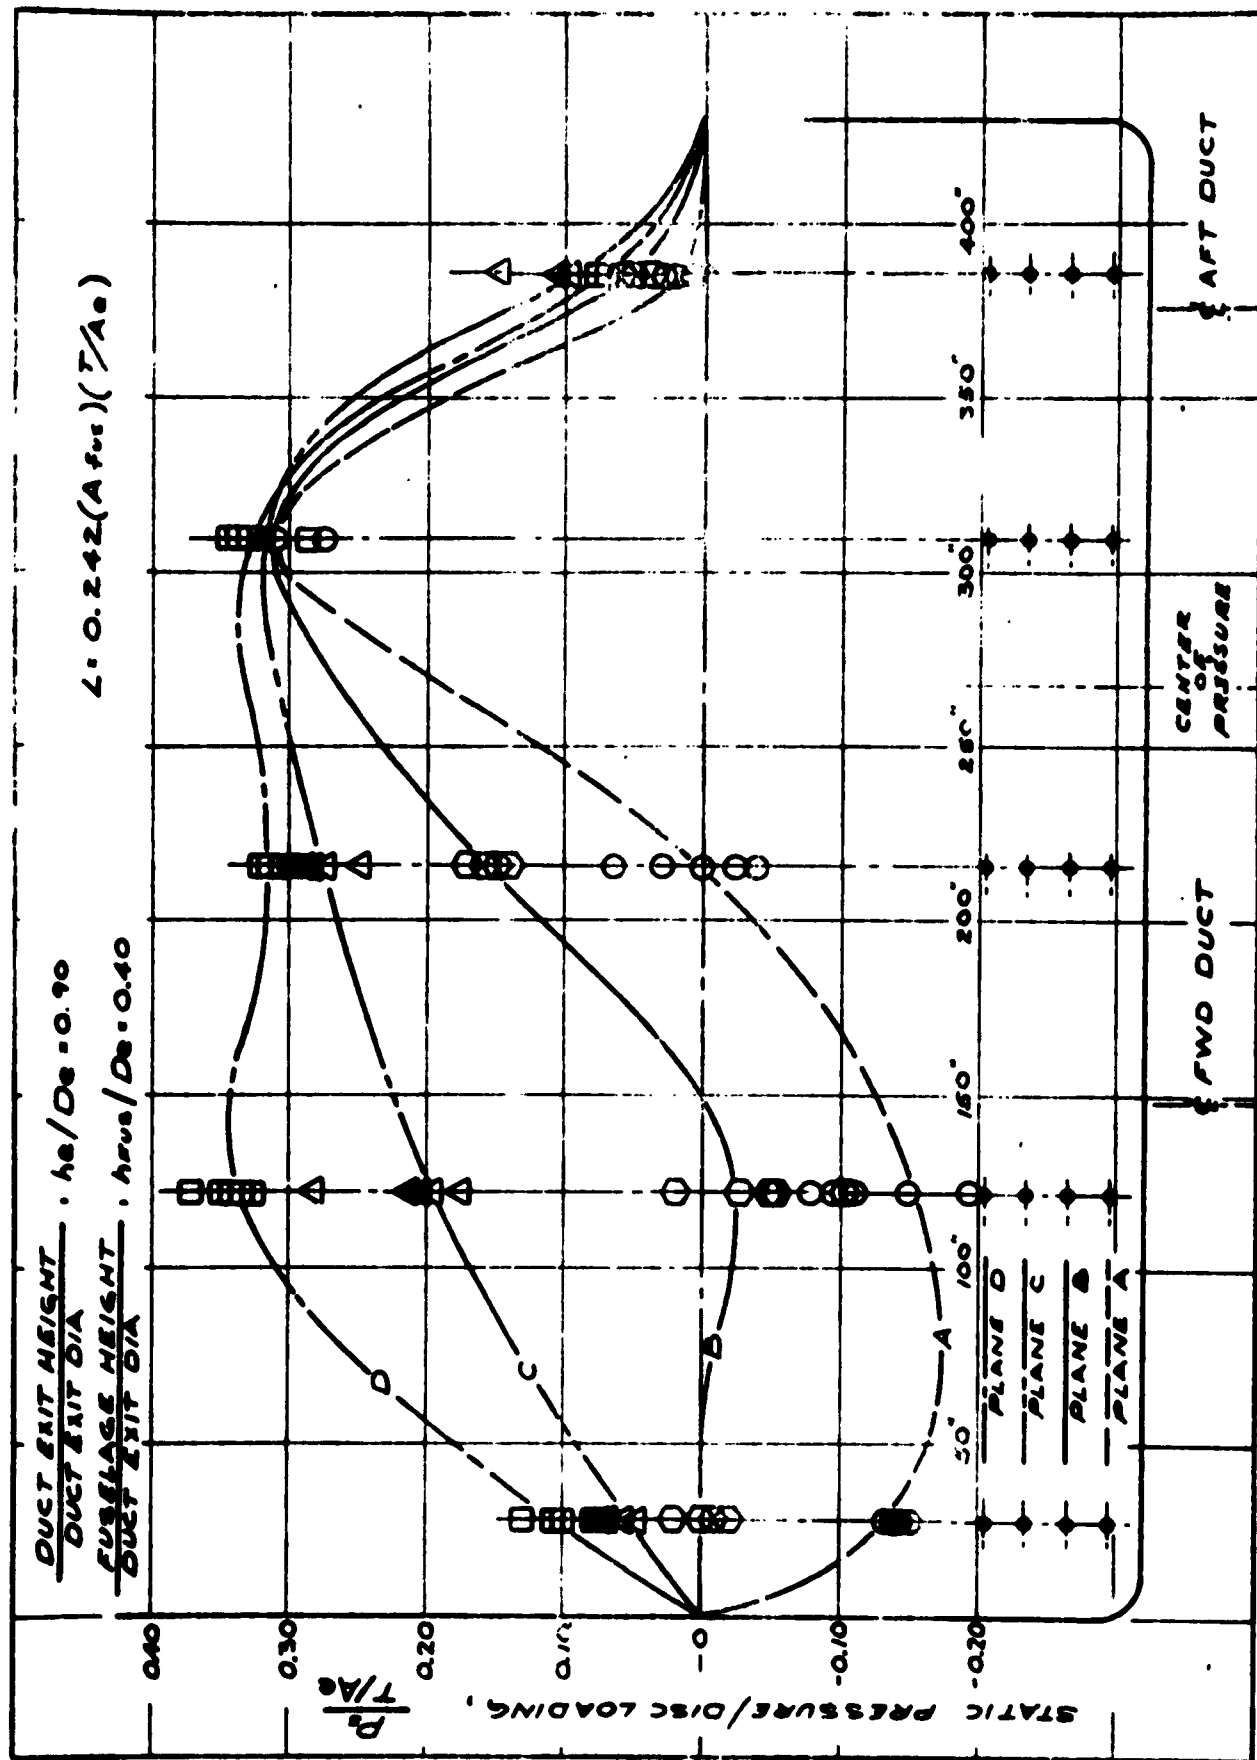
FIGURE 17. STATIC PRESSURE DISTRIBUTION ON THE BOTTOM SURFACE OF THE FUSELAGE, MODIFIED CONFIGURATION
